Y-Bridge
Spans the confluence of Muskingum and Licking Rivers
Zanesville
Muskingum County
Ohio

HAER NO. OH-22

Y-Bridge

Significance: The Y-Bridge was one of the early bridges in the
United States to use concrete and steel construction.
At the time it was built, it was the only bridge in
the United States with a Y configuration. The bridge
was designed by Edward Landor, who used the Thacher
patent system of construction. The Y-Bridge, along
with the three wooden bridges it replaced, has been a
part of the national road system since the eighteenth
century.

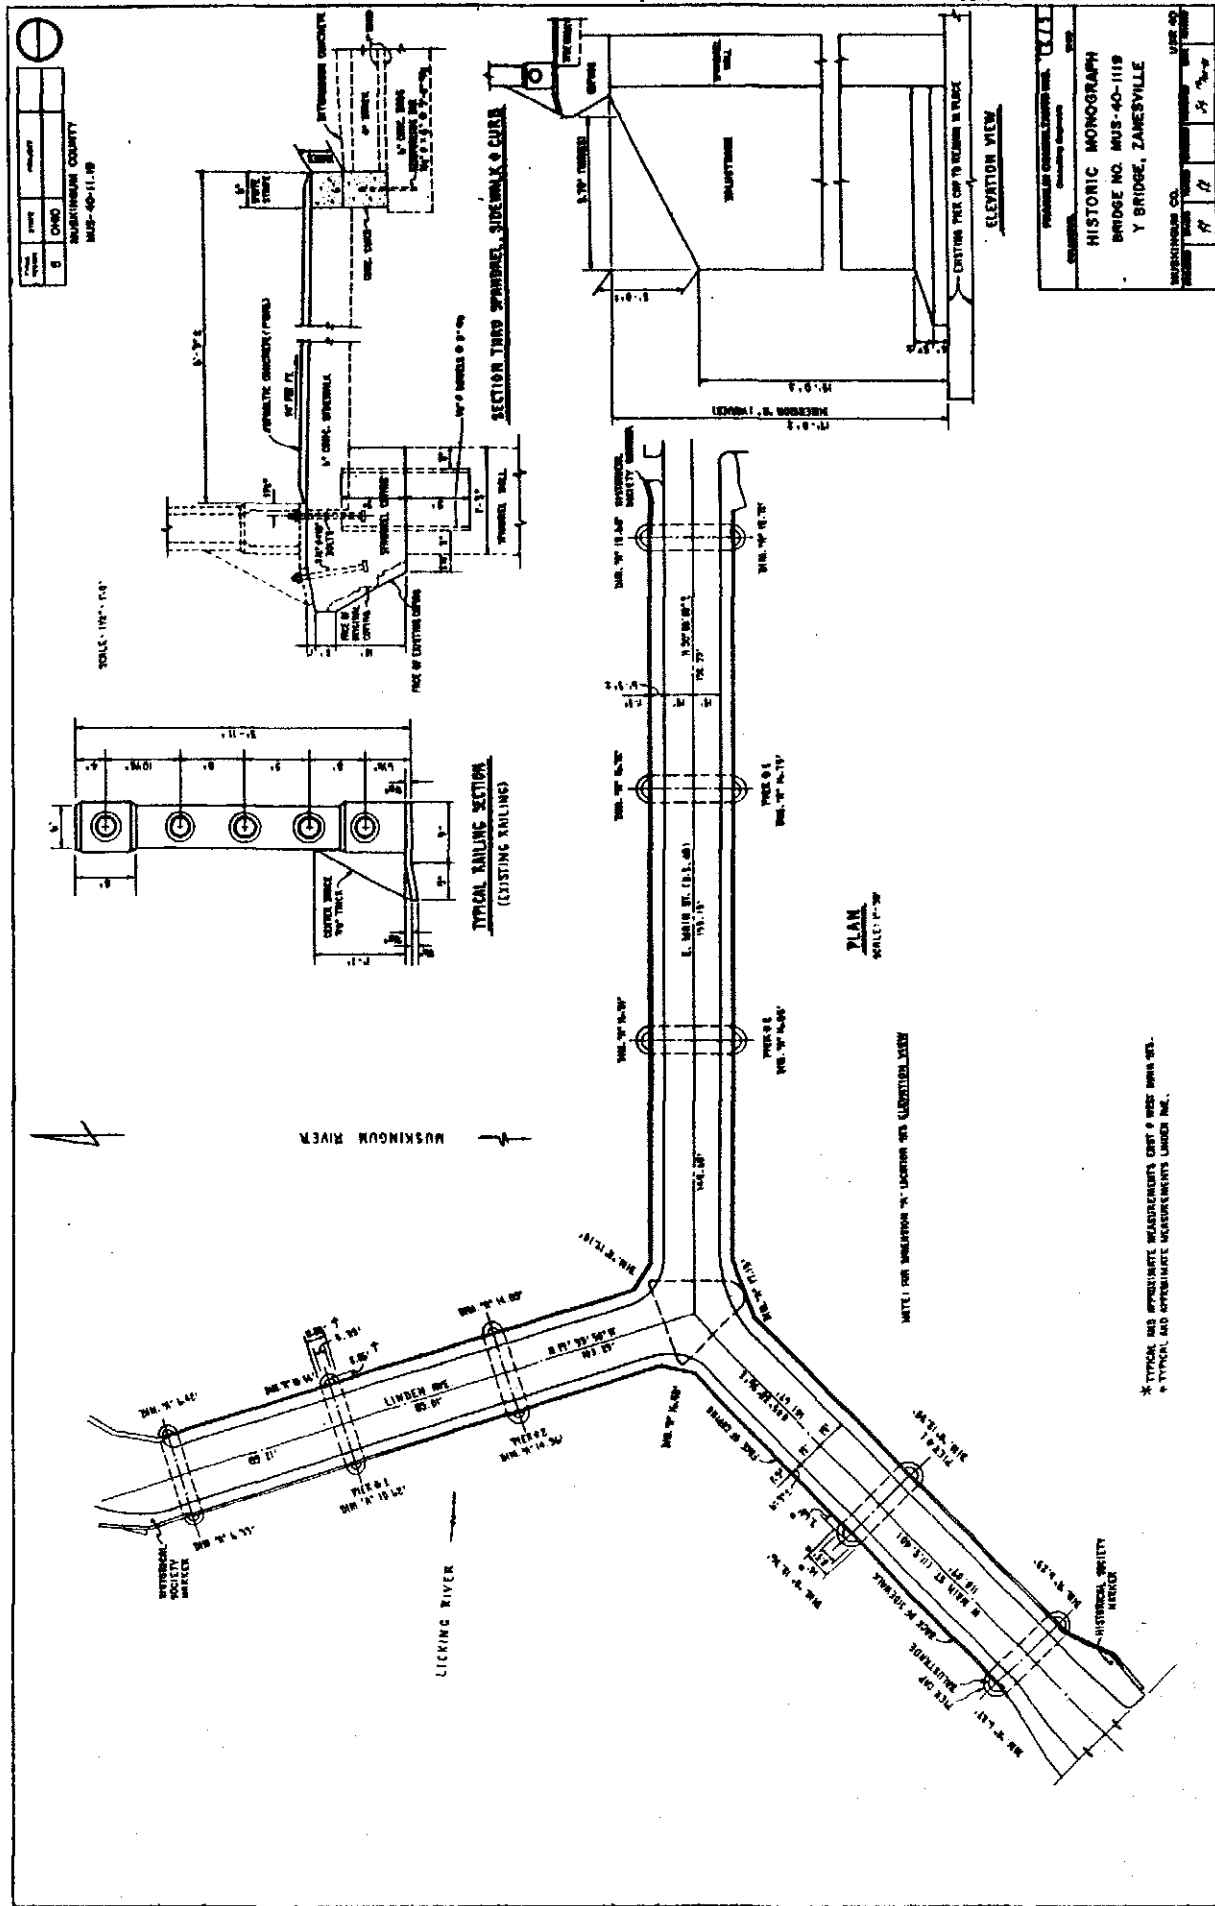
LOCATION MAP FOR HAER PHOTOGRAPHS

THIS PLAN VIEW SHOWS THE LOCATION AND STRUCTURE OF EACH PHOTOGRAPH

SCALE 1" = 50'-0"

Dimensions of the spans and arches are shown on the attached site plan.
